Extrication Challenges of Advanced Steel In Vehicles: Part 4 – Power Cutters

- SUBJECT:** Advanced Steel
TOPIC: Extrication Challenges of Advanced Steel in Vehicles: Part 4
OBJECTIVE: The rescuer will understand and explain the capabilities and limitations of various hydraulic-powered rescue cutter tools
TASK: Given the information presented in Part 4 of this series, the rescuer will demonstrate the steps necessary to effectively operate a power cutter to cut through the advanced steel structural areas of a late-model passenger vehicle.

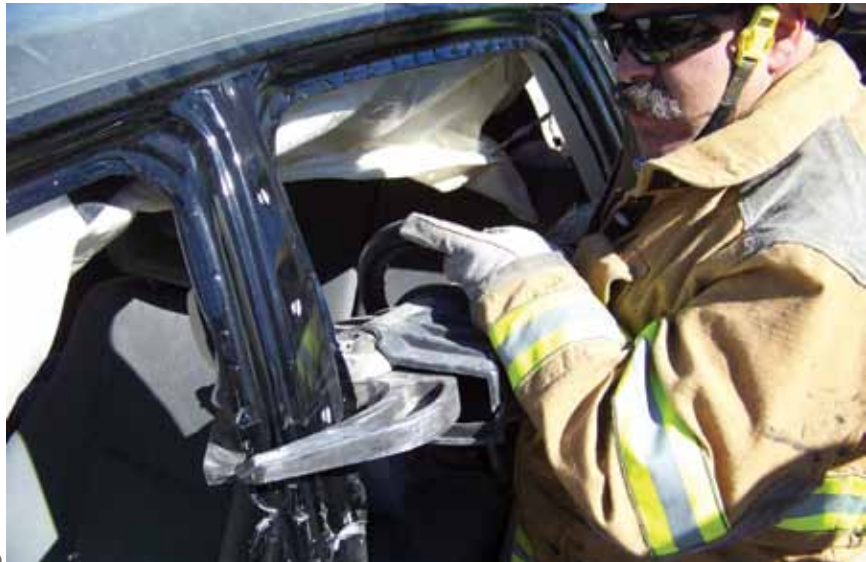
The most successful tool position for cutting through a Boron B-pillar was this "parallel" position. The blades were able to close more before cutting into the metal, letting them generate a greater force than if they were loaded while fully opened.

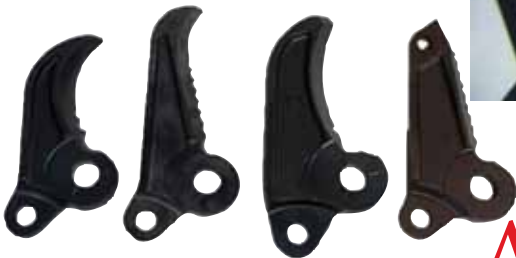
One of the lessons learned thus far is that blade design can be a significant factor in whether a power rescue tool cutter will be able to cut through advanced steel. Shown are examples of combination radius/serrated, elliptical, radius and serrated blades.

- Blade shape or design may be another significant factor as well. The Boron testing evaluated different blade designs; radius, elliptical, serrated and a combination radius/serrated unit. There were successes and failures with each style. Many times, the common radial blade design caused the tool to crush the multiple layers of metal into a tight bundle before it was able to try to cut the B-pillar. In some cases where the power of a tool was marginal, the crushing would occur and then the tool would stall out. In cases where serrations in the cutting edges of the blades allowed the pillar or roof rail to start tearing initially as the blades closed, the cutter may make it through the Boron.

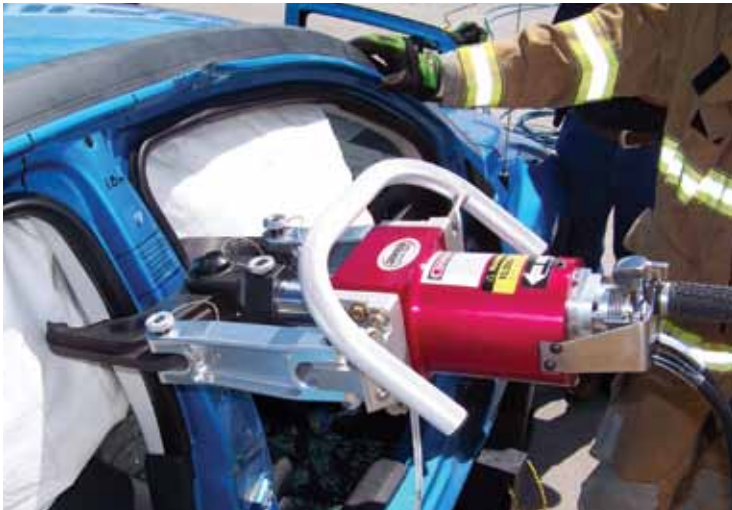
The Champion Beast with their USAR cutter blades is shown being tested on the B-pillar of a 2008 Dodge Caliber. This specific spot on our test vehicles contained the thickest 1.9mm Boron steel hidden inside the pillar.
